Tree Inventory Plan
Water Street
Warren, Rhode Island

Client
Town of Warren
514 Main Street
Warren, Rhode Island 02885

DE Job No. 1645-002 Copyright 2012 by DiPrete Engineering Associates, Inc.

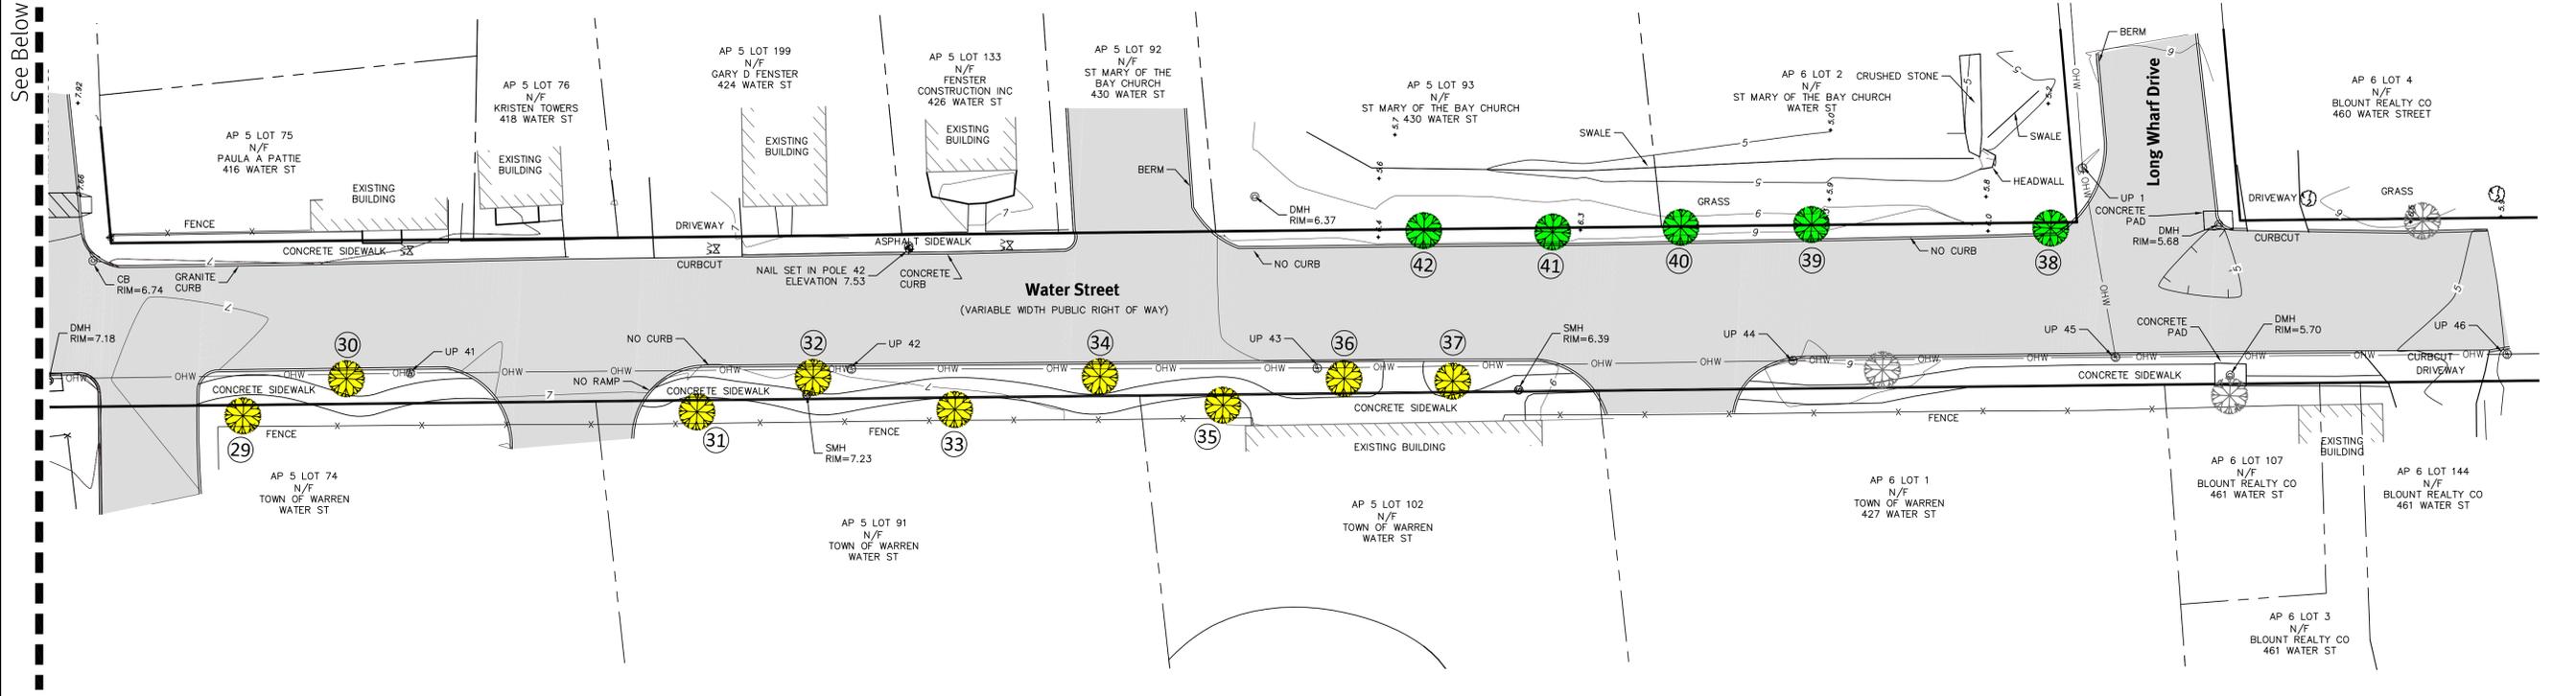
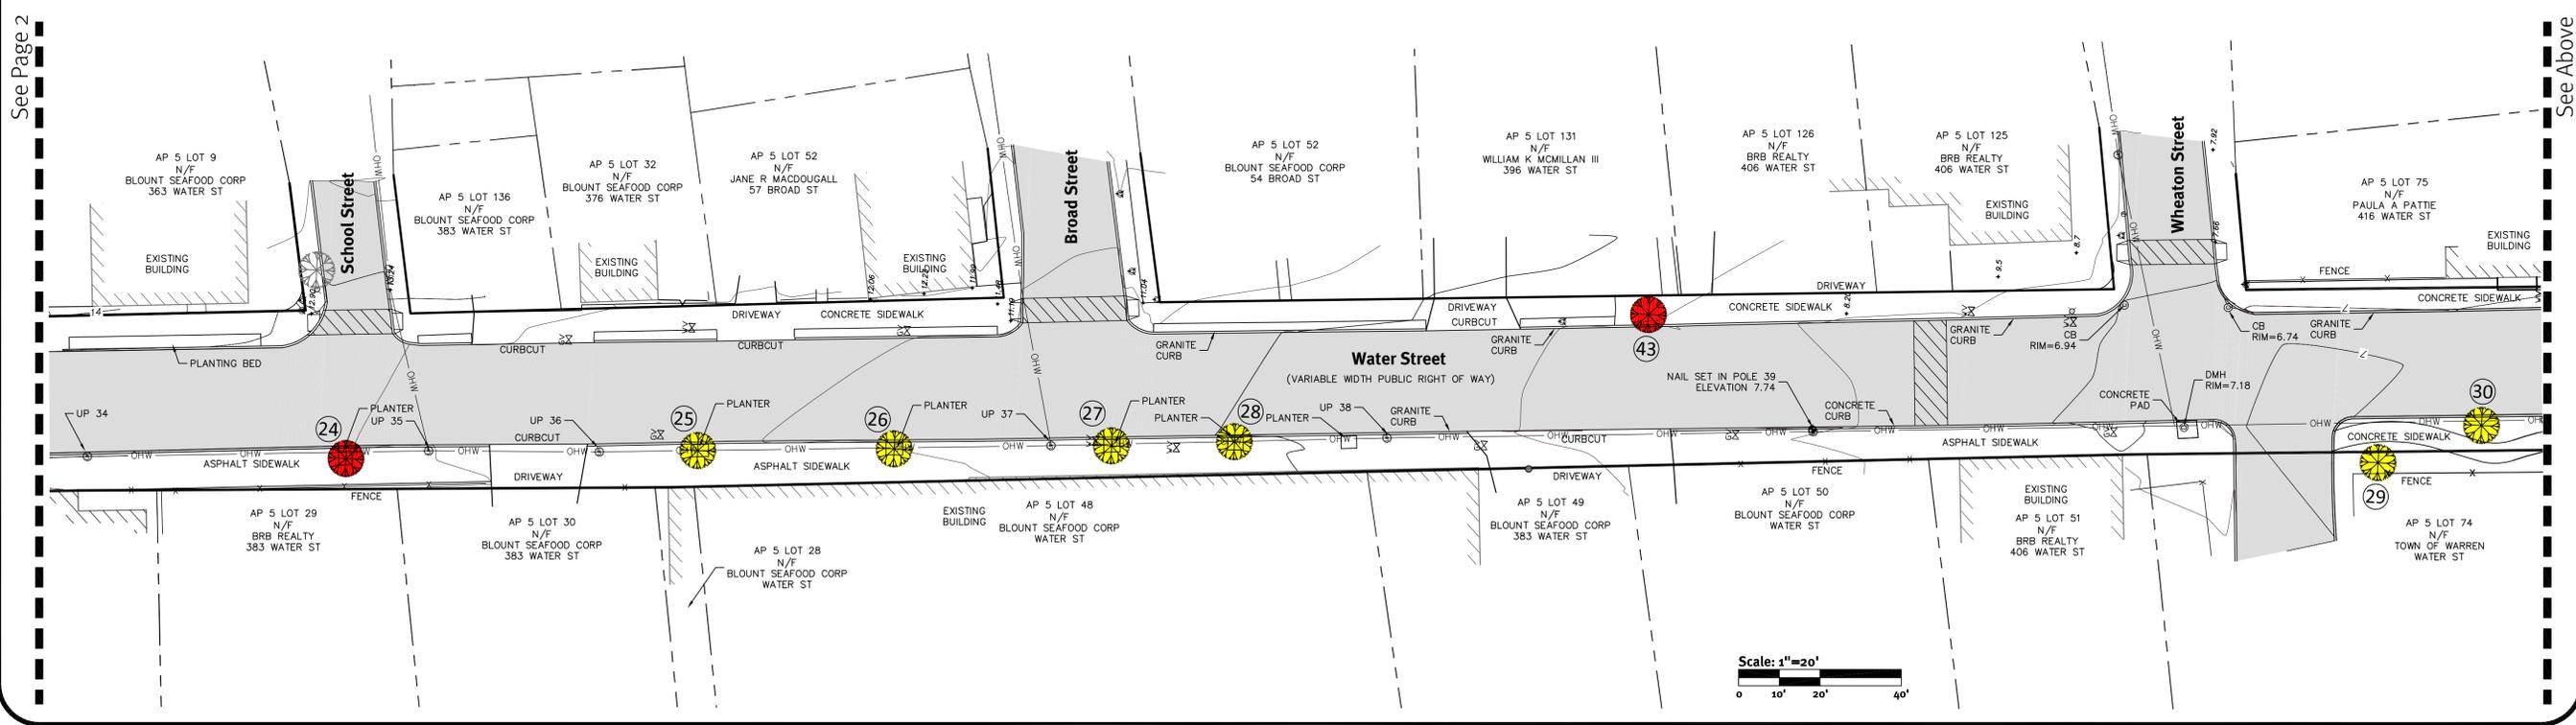
Tree No.	Species	Trunk Caliper	Existing and Potential Root Growth Conflicts	Overall Tree Health and Conditions
24	Green Ash	17"	Major - major upheaval of sidewalk, encroachment into sidewalk, exposed roots, future worsening of heaving and curb displacement likely due to inadequate tree pit dimensions, provides insufficient space for reconstructed sidewalk	Poor - branching conflicts with overhead wires, health of tree is declining, central branches out to accommodate overhead wires, tree is leaning [growing over roadway and parking lot posing significant safety hazard, large trunk cavity on main trunk, trunk damage observed at base of tree, tree is too large for area
25	Hawthorne	8"	Minor - minor upheaval of sidewalk, future worsening of heaving and curb displacement likely due to inadequate tree pit dimensions	Good [Fair] - branching conflicts with overhead wires, thinned tree species are dangerous and inappropriate for sidewalk areas, may require pruning to meet ADA branching height requirements at sidewalk

26	Hawthorne	7"	Minor - minor upheaval of sidewalk, future worsening of heaving and curb displacement likely due to inadequate tree pit dimensions	Good [Fair] - branching conflicts with overhead wires, thinned tree species are dangerous and inappropriate for sidewalk areas, may require pruning to meet ADA branching height requirements at sidewalk
27	Hawthorne	8"	None - future heaving and curb displacement likely due to inadequate tree pit dimensions	Good [Fair] - branching conflicts with overhead wires, thinned tree species are dangerous and inappropriate for sidewalk areas, may require pruning to meet ADA branching height requirements at sidewalk
28	Hawthorne	8"	None - future heaving and curb displacement likely due to inadequate tree pit dimensions	Good [Fair] - branching conflicts with overhead wires, thinned tree species are dangerous and inappropriate for sidewalk areas, may require pruning to meet ADA branching height requirements at sidewalk

29	Norway Maple	15"	Moderate - gridded roots, exposed roots, future heaving likely due to proximity of tree to sidewalk	Fair - branching conflicts with overhead wires, some central branches out to accommodate overhead wires, requires pruning to meet ADA branching height requirements at sidewalk
30	Norway Maple	15"	Moderate - gridded roots, exposed roots, future heaving and curb displacement likely due to limited plant bed width	Poor - branching conflicts with overhead wires, health of tree is declining, central branches out to accommodate overhead wires, tree has been heavily pruned to remove dead wood, may require pruning to meet ADA branching height requirements at sidewalk, tree may be near end of normal life cycle
31	Crimson King Norway Maple	12"	None - future heaving likely due to proximity of tree to sidewalk	Good [Fair] - branching conflicts with overhead wires, requires pruning to meet ADA branching height requirements at sidewalk

32	Norway Maple	17"	Minor - curb displacement, future heaving and worsening of curb displacement likely due to limited plant bed width, potential conflict with sewer manhole	Poor - branching conflicts with overhead wires, health of tree is declining, central branches out to accommodate overhead wires, some prior trunk damage observed, weak limbs unions observed creating higher likelihood of limb breakage or structural failure, tree may be near end of normal life cycle
33	Crimson King Norway Maple	12"	Minor - gridded roots, exposed roots, future heaving likely due to proximity of tree to sidewalk	Good [Fair] - branching conflicts with overhead wires, requires pruning to meet ADA branching height requirements at sidewalk

Tree No.	Species	Trunk Caliper	Existing and Potential Root Growth Conflicts	Overall Tree Health and Conditions
34	Norway Maple	21"	Moderate - gridded roots, exposed roots, future heaving and curb displacement likely due to limited plant bed width	Fair - branching conflicts with overhead wires, health of tree is declining, central branches out to accommodate overhead wires, tree is leaning [growing over roadway and parking lot posing significant safety hazard, large trunk cavity on main trunk, trunk damage observed at base of tree, tree is too large for area]
35	Kwanan Cherry	18"	Moderate - moderate upheaval of sidewalk, gridded roots, exposed roots, future worsening of heaving likely due to proximity of tree to sidewalk	Good [Fair] - branching conflicts with overhead wires, thinned tree species are dangerous and inappropriate for sidewalk areas, may require pruning to meet ADA branching height requirements at sidewalk

36	Norway Maple	19"	None	None
37	Kwanan Cherry	16"	None - future heaving likely due to proximity of tree to sidewalk	Good [Fair] - branching conflicts with overhead wires, thinned tree species are dangerous and inappropriate for sidewalk areas, may require pruning to meet ADA branching height requirements at sidewalk
38	Red Maple	11"	Moderate - gridded roots, exposed roots, encroachment into roadway, may provide insufficient space for future sidewalk or curbing	Fair - branching conflicts with overhead wires, health of tree is declining, central cavity on main trunk and branches observed, location of tree inside the distance at intersection
39	Red Maple	9"	Minor - exposed roots, may provide insufficient space for future sidewalk	Good [Fair] - health of tree is declining, dead branches observed, weak limbs unions observed creating higher likelihood of limb breakage or structural failure
40	Norway Maple	12"	None - may provide insufficient space for future sidewalk	Fair - dead branches observed, cavity on main trunk, trunk damage observed

41	Red Maple	7"	None - may provide insufficient space for future sidewalk	Good [Fair] - cavity on branches observed
42	Red Maple	11"	Minor - exposed roots, may provide insufficient space for future sidewalk	Good [Fair] - tree is leaning [growing over roadway posing significant safety hazard, cavity on main trunk observed, trunk damage observed, spaced in crown for weak limbs unions creating higher likelihood of limb breakage or structural failure, tree too large for area]
43	Silver Maple	49"	Major - major upheaval of adjacent ground, encroachment into roadway and sidewalk, sidewalk removal performed, exposed roots, curb displacement, future worsening of heaving likely due to inadequate tree pit dimensions, provides insufficient space for reconstructed sidewalk or curbing	Good [Fair] - tree is leaning [growing over roadway posing significant safety hazard, cavity on main trunk observed, trunk damage observed, spaced in crown for weak limbs unions creating higher likelihood of limb breakage or structural failure, tree too large for area]
