Tree Inventory Plan
Water Street
Warren, Rhode Island

Town of Warren
Client
514 Main Street
Warren, Rhode Island 02885

SHEET 2 OF 14

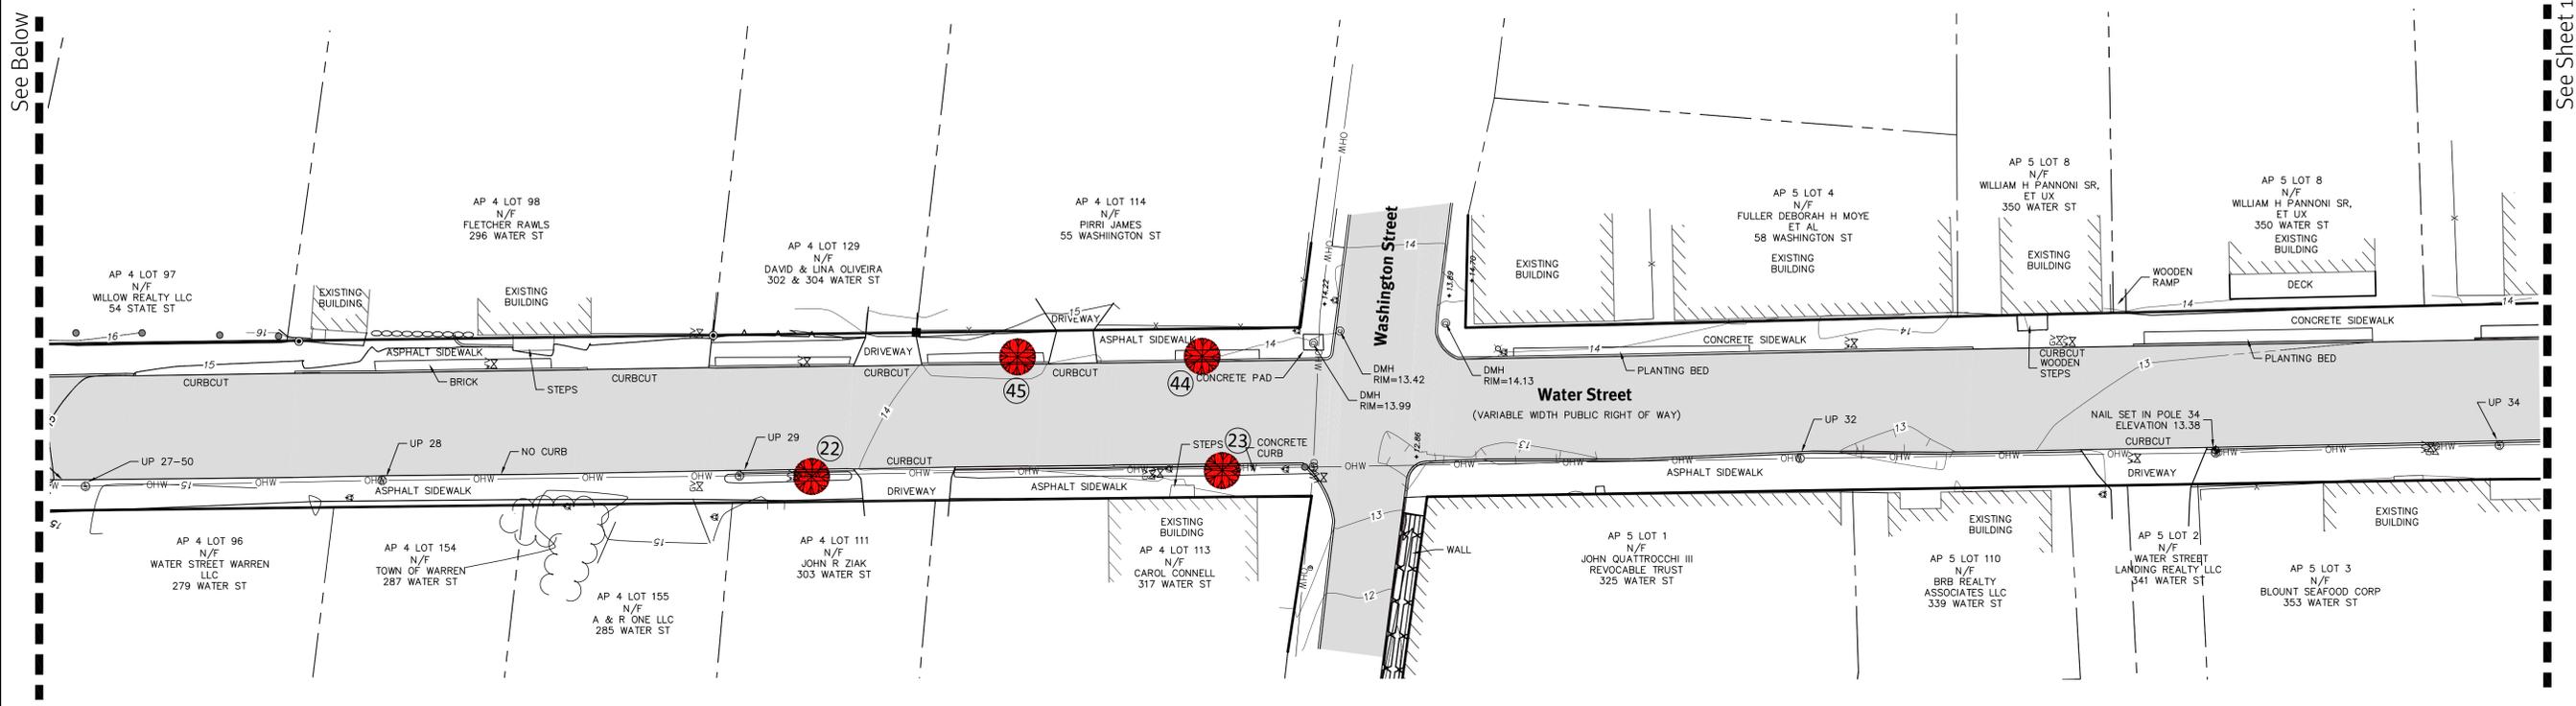
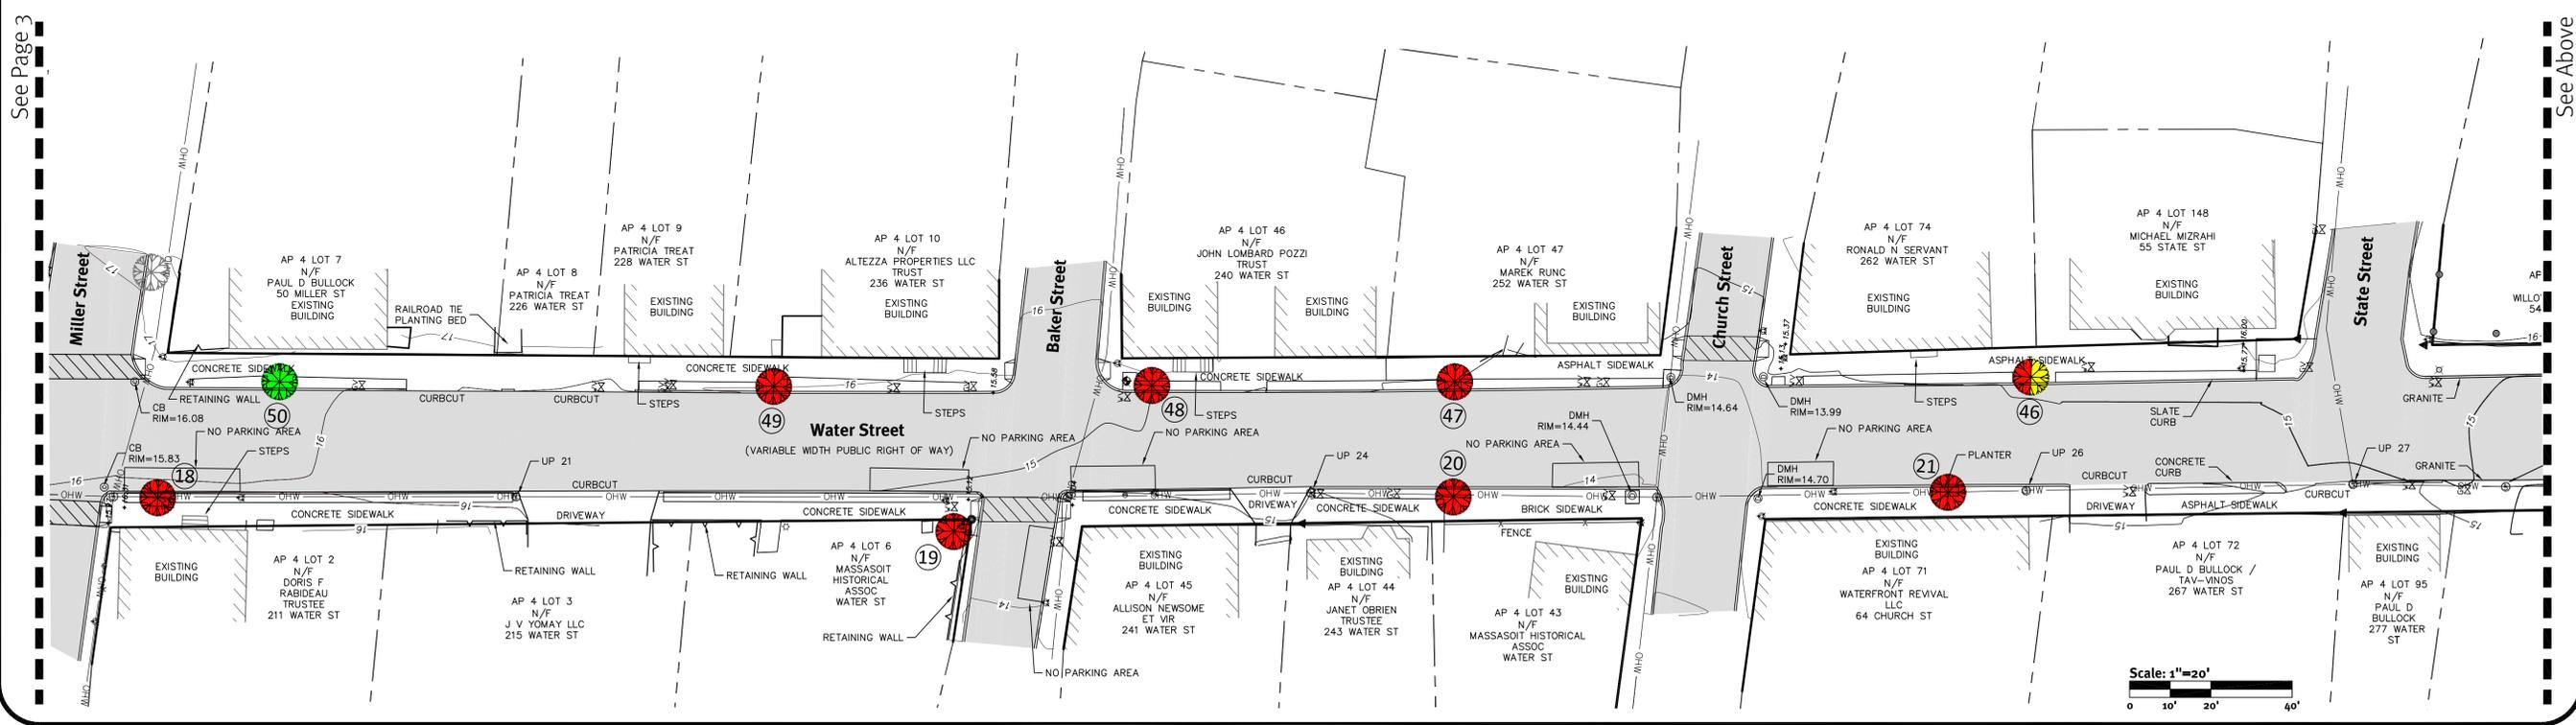
Tree No.	Species	Trunk Caliper	Existing and Potential Root Growth Conflicts	Overall Tree Health and Conditions
18	Norway Maple	15"	Moderate - Minor upheaval of sidewalk, exposed roots, curb displaced, future worsening of heaving and curb displacement likely due to inadequate tree pit dimensions.	Poor - Branching conflicts with building and overhead wires, health of tree is declining, some central branches cut to accommodate overhead wires, section bearing [growing over roadway posing significant safety hazard, dead branches observed, large trunk cavity] cavity on main trunk, tree is too large for area.
19	Northern Catalpa (Stump)	42"	Major - major upheaval of sidewalk, encroachment into sidewalk, exposed roots, exposed roots.	Dead - Only a stump remains in this location.
20	Bradford Cakery Pear	7"	None - future heaving and curb displacement likely due to inadequate tree pit dimensions.	Fair - Branching conflicts with overhead wires, requires pruning to meet ADA branching height requirements at sidewalk, species is known for weak limb unions creating higher likelihood of limb breakage or structural failure.

21	Japanese Zilvna	15"	Moderate - moderate upheaval of sidewalk, future worsening of heaving and curb displacement likely due to inadequate tree pit dimensions, provides insufficient space for reconstructed sidewalk or curbing.	Poor - Branching conflicts with building and overhead wires, health of tree appears to be declining, center of tree cut to accommodate overhead wires, large section bearing [growing over building posing safety hazard, significant portion of branches are dead at top of tree, tree is too large for area.
22	Norway Maple	17"	Major - major upheaval of sidewalk, encroachment into sidewalk, exposed roots, curb displaced, future worsening of heaving and curb displacement likely due to inadequate tree pit dimensions, provides insufficient space for reconstructed sidewalk or curbing.	Fair - Branching conflicts with building and overhead wires, some central branches cut to accommodate overhead wires, section bearing [growing over roadway posing significant safety hazard, tree is too large for area.

23	Honey Locust	10"	Moderate - Minor upheaval of sidewalk, curb displaced, future worsening of heaving and curb displacement likely due to inadequate tree pit dimensions, provides insufficient space for reconstructed sidewalk or curbing.	Poor - Branching conflicts with building and overhead wires, heavily pruned limbs on west side, central branches cut to accommodate overhead wires, tree is leaning [growing over roadway posing significant safety hazard, trunk damage observed at base of tree, tree is too large for area.
44	Honey Locust	15"	Major - major upheaval of sidewalk, encroachment into sidewalk, exposed roots, curb displaced, future worsening of heaving and curb displacement likely due to inadequate tree pit dimensions, provides insufficient space for future sidewalk or curbing.	Fair - Branching will conflict with building in the future, trunk damage observed.
45	Honey Locust	11"	Major - major upheaval of sidewalk, encroachment into sidewalk, exposed roots, curb displaced, future worsening of heaving and curb displacement likely due to inadequate tree pit dimensions, may provide insufficient space for future sidewalk or curbing.	Fair - [Poor - health of tree declining, tree is leaning] [growing over sidewalk posing safety hazard]

Tree No.	Species	Trunk Caliper	Existing and Potential Root Growth Conflicts	Overall Tree Health and Conditions
46	Red Oak	24"	Major - major upheaval of sidewalk, encroachment into sidewalk, exposed roots, curb displaced, future worsening of heaving and curb displacement likely due to inadequate tree pit dimensions, provides insufficient space for reconstructed sidewalk or curbing.	Good [Fair - Branching conflicts with buildings and overhead wires, trunk damage observed, tree is too large for area]
47	Amur Cork Tree	4"	None - future heaving likely due to inadequate tree pit dimensions.	Poor [Heavily Dead - Branching has been pruned] [damaged, tree has minimal foliage]
48	Norway Maple	9"	Moderate - minor upheaval of sidewalk, curb displaced, future worsening of heaving and curb displacement likely due to inadequate tree pit dimensions, provides insufficient space for reconstructed sidewalk or curbing.	Fair [Poor - Branching will soon conflict with building and overhead wires, health of tree is declining, dead branches observed, weak limb unions observed creating higher likelihood of limb breakage or structural failure]

49	Norway Maple	20"	Major - moderate upheaval of sidewalk, exposed roots, curb displaced, future worsening of heaving and curb displacement likely due to inadequate tree pit dimensions, provides insufficient space for reconstructed sidewalk or curbing.	Good [Fair - Branching conflicts with building and overhead wires, large section is leaning [growing toward building posing safety hazard, tree is too large for area, tree may be near end of normal life cycle]
50	Climax King Norway Maple	3"	None - future heaving and curb displacement likely due to inadequate tree pit dimensions.	Fair - Branching will conflict with building in the future, trunk damage observed.

- REMOVE AND DISPOSE OF EXISTING TREE AND ROOT SYSTEM
- MONITOR EXISTING TREE CONDITIONS - REMOVAL AND DISPOSAL OF TREE AND ROOT SYSTEM LIKELY
- MONITOR EXISTING TREE CONDITIONS - RECOMMENDED ACTION TO BE DETERMINED
- MAINTAIN AND PROTECT EXISTING TREE AND ROOT SYSTEM
- EXISTING TREE LOCATED OUTSIDE OF PROJECT AREA - NO ACTION REQUIRED
- TREE IDENTIFICATION NUMBER FOR INVENTORY
