**Existing and Potential Root Growth Conflicts**

**Overall Tree Health and Conditions**

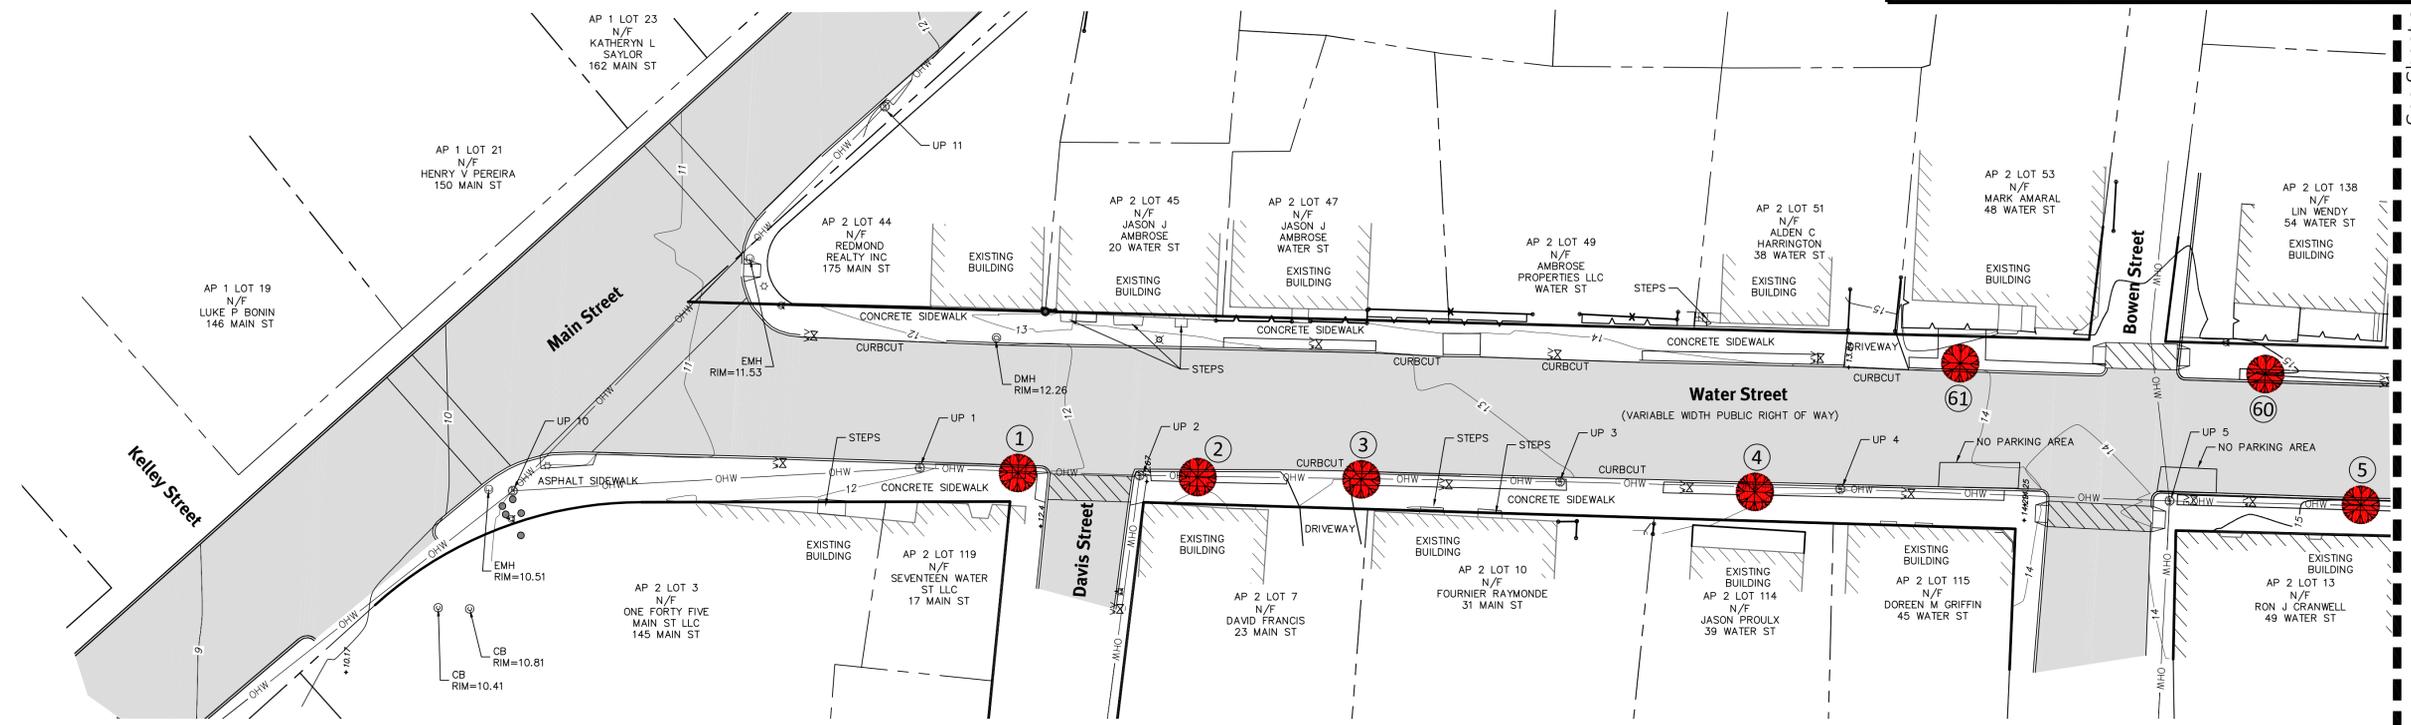
Tree No.	Species	Trunk Caliper
1	Kwanan Cherry	8"
2	Clmson King Norway Maple	7"
3	Amur Cork Tree	12"
4	Norway Maple	18"
5	Honey Locust	16"
60	Norway Maple	10"
61	Norway Maple	13"

Minor - Minor upheaval of sidewalk, future worsening of heaving and curb displacement likely due to inadequate tree pit dimensions

Major - Major upheaval of sidewalk, girdled roots, exposed roots, curb displacement, future worsening of heaving and curb displacement likely due to inadequate tree pit dimensions, provides insufficient space for reconstructed curbing

Fair - Branching conflicts with building and overhead wires, dead branches observed, tree is too large for area

Poor - Branching conflicts with building and overhead wires, center of tree out to accommodate overhead wires, dead branches observed, tree is too large for area

Very Poor - Branching conflicts with building and overhead wires, center of tree out to accommodate overhead wires, large section leaning, growing over roadway posing safety hazard, tree is too large for area

Poor - Branching conflicts with building and overhead wires, health of tree is declining, top has been pruned several times in the past, tree is leaning, growing toward building posing safety hazard, some dead branches observed, canker cavity on at base of tree observed

Fair - Branching conflicts with building and overhead wires, tree is slightly leaning over street, trunk damage observed, large canker cavity at base of tree, weak limb or limb observed, coating higher likelihood of limb breakage or structural failure, tree is becoming too large for area, tree may be near end of normal life cycle
